American Home Inspections of NE NC

Page 1 of 23
Unit #46010A

Property Address US Coast Guard Housing, Unit #46010A Kinnakeet Rd

Client Name U S Coast Guard

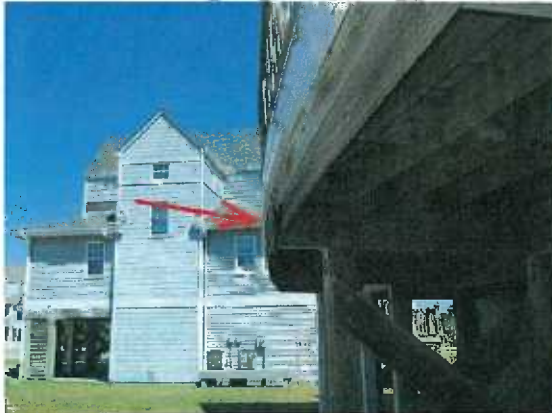
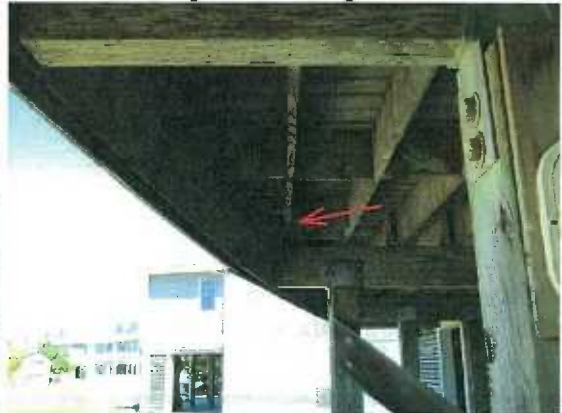
| 4. | <input type="checkbox"/> | <input type="checkbox"/> | <input type="checkbox"/> | <input type="checkbox"/> | <input type="checkbox"/> | <input checked="" type="checkbox"/> | Deck: Front, Pressure Treated Wood The lower front trim boards are loose and beginning to fall. There is one floor joist near the front of the deck that is not properly supported with a metal joist hanger. Several of the handrail pickets are loose and out of place. Close inspection revealed that the nails used to fasten the pickets to the top and bottom rails are rusty and deteriorated and failing to perform their intended function. There is one floor joist near the front of the deck that is not properly supported with a metal joist hanger. |

1. **Deck: Front, Pressure Treated Wood** The lower front trim boards are loose and beginning to fall. There is one floor joist near the front of the deck that is not properly supported with a metal joist hanger. Several of the handrail pickets are loose and out of place. Close inspection revealed that the nails used to fasten the pickets to the top and bottom rails are rusty and deteriorated and failing to perform their intended function. There is one floor joist near the front of the deck that is not properly supported with a metal joist hanger.

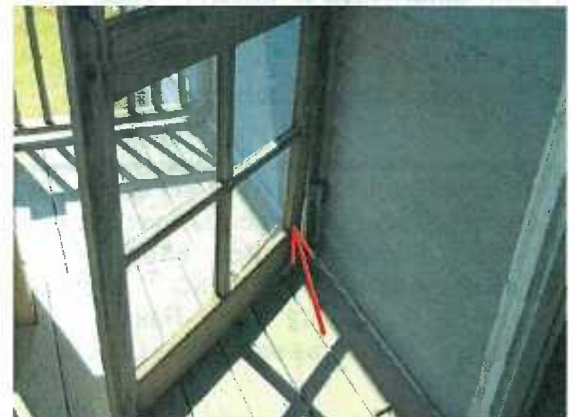
5. ☐ ☐ ☐ ☐ ☒ Porch: Rear Porch, Pressure Treated Wood
The porch screen door is damaged.

2. **Porch: Rear Porch, Pressure Treated Wood** The porch screen door is damaged.

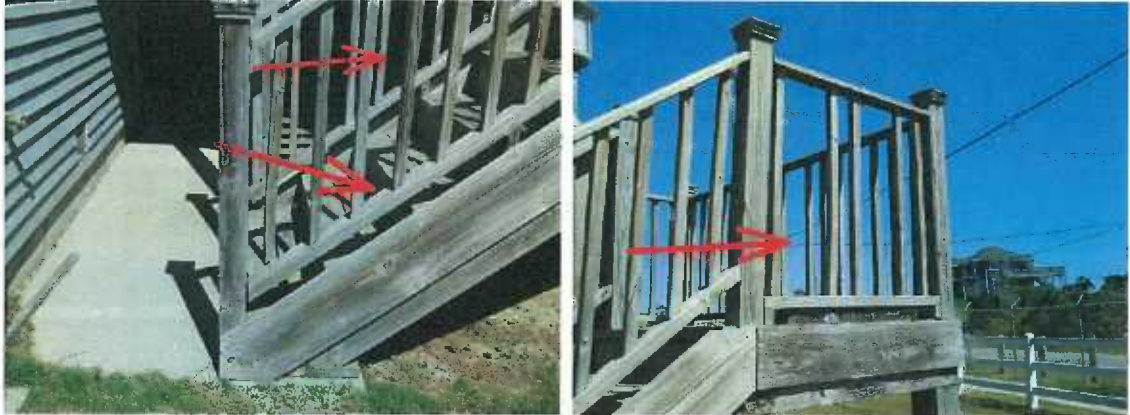
6. ☐ ☐ ☐ ☐ ☒ Stairs/Landing: Rear Stairs & Landing, Pressure Treated Wood The wood pickets are loose or out of place. The nails used to secure the pickets are rusty/deteriorated.

3. **Stairs/Landing: Rear Stairs & Landing, Pressure Treated Wood** The wood pickets are loose or out of place. The nails used to secure the pickets are rusty/deteriorated.

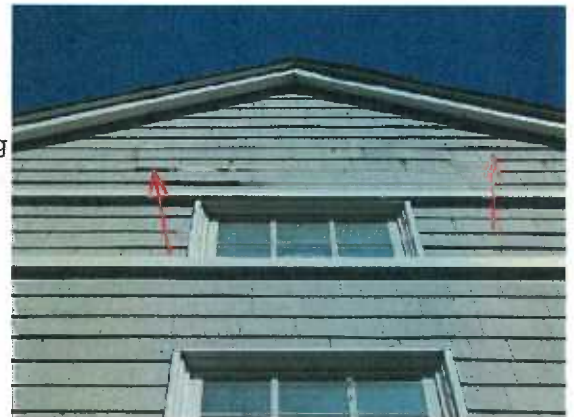
8. ☐ ☐ ☐ ☒ ☐ Type: Plywood Panels with machine shake appearance. The machine shake look plywood panels, the nails are loose in several places. The exterior walls should be examined and the loose siding re nailed. The exterior of the house should be pressure washed and repainted.

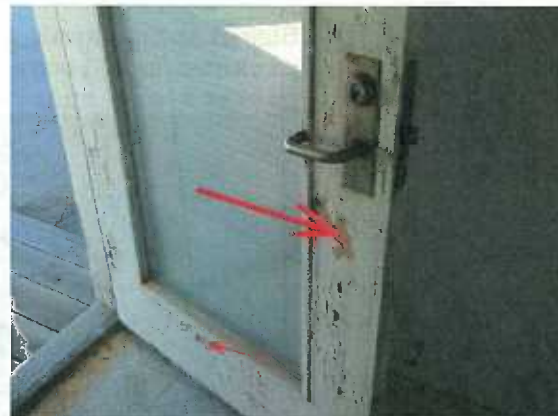
12. ☐ ☐ ☐ ☒ ☐ Entry Doors: Ground Front, Fiberglass, Full View Glass Paint is peeling from the door surface. It needs to be re painted.

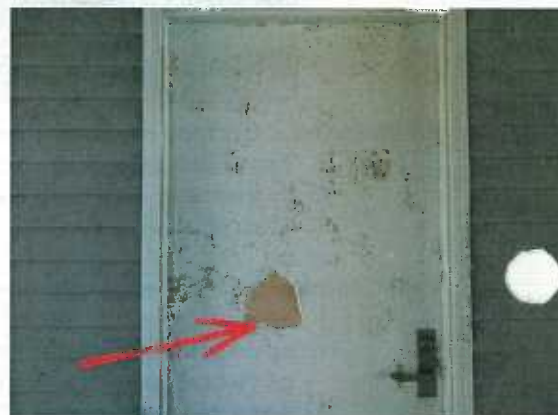
13. ☐ ☐ ☐ ☒ ☐ Entry Door: Ground Utility Room, Fiberglass, Flush Solid Core Paint is peeling from the door surface. It needs to be repainted.

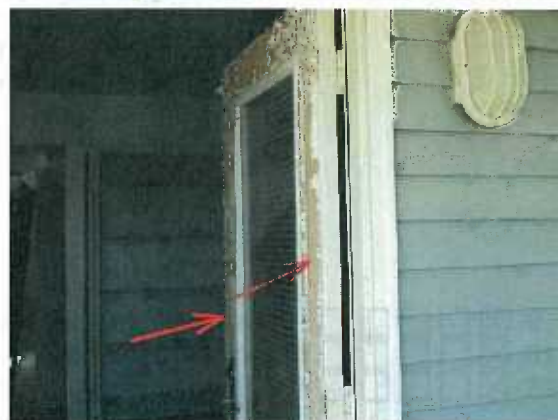
14. ☐ ☐ ☐ ☒ ☐ Entry Door: Main Living Area, Fiberglass, Full View Glass Paint is peeling from the door surface. It needs to be re painted.

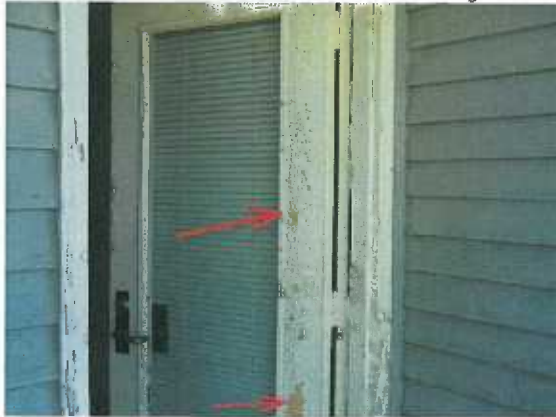
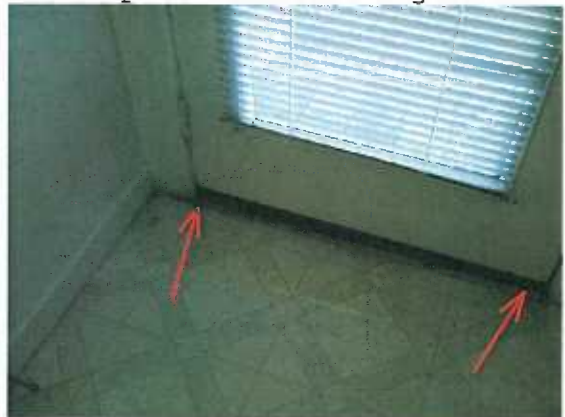
15. ☐ ☐ ☐ ☐ ☒ Entry Door: Kitchen/Dining Area, Fiberglass, Full view Glass Paint is peeling from the door surface. It needs to be re painted. Moisture is migrating to the inside at the door threshold. The door and threshold need to be adjusted to stop the moisture migration.

4. Entry Door: Kitchen/Dining Area, Fiberglass, Full view Glass Paint is peeling from the door surface. It needs to be re painted. Moisture is migrating to the inside at the door threshold. The door and threshold need to be adjusted to stop the moisture migration.

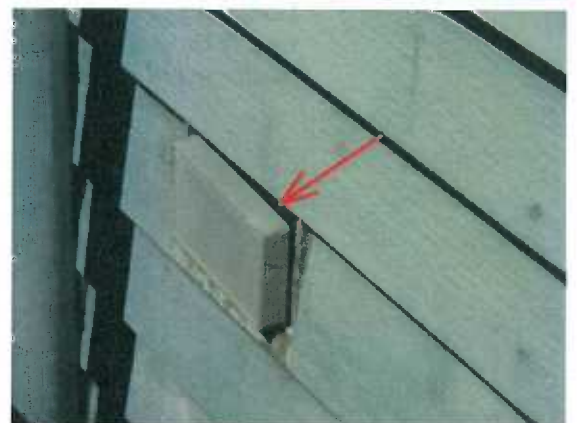
19. ☐ ☐ ☐ ☒ ☐ Exterior Electric Outlets: Exterior, Surface Mount
The exterior electrical outlets are not properly mounted to the wall.

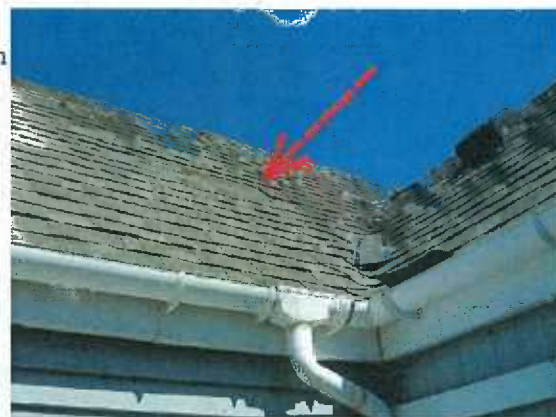
2. ☐ ☐ ☐ ☐ ☒ Material: Asphalt shingle The roof is missing shingles on the north and south sides.

6. All Roof Areas Roof Surface Material: Asphalt shingle The roof is missing shingles on the north and south sides.
7. Ventilation Vent: Bath Fan Ventilation Looking at the roof sheathing, you can see that it is deteriorated around the duct work for the ventilation fan.

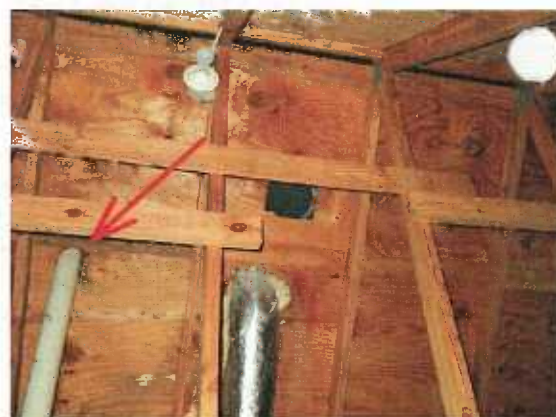
7. ☐ ☐ ☐ ☒ ☐ Plumbing Vents: PVC When inside the attic, you can see daylight around the edges of the 3 inch vent pipe. This is a good indication that is leaking.

| 9. | <input type="checkbox"/> | <input type="checkbox"/> | <input type="checkbox"/> | <input type="checkbox"/> | <input checked="" type="checkbox"/> | Moisture Penetration: Ongoing water penetration noted As noted before, the 3 inch PVC pipe appears to be leaking as well as the vent for the bath ventilation fan. |

9. Main Attic Moisture Penetration: Ongoing water penetration noted As noted before, the 3 inch PVC pipe appears to be leaking as well as the vent for the bath ventilation fan.

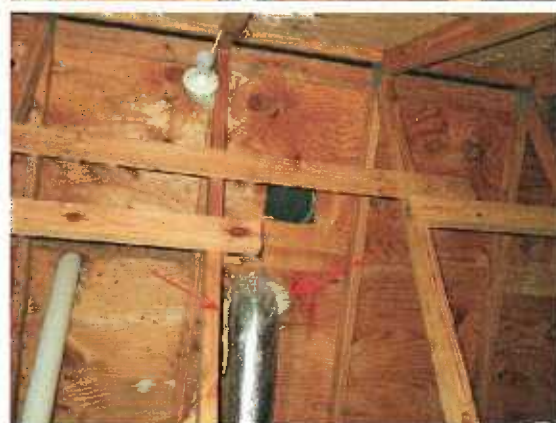
8. ☐ ☐ ☐ ☐ ☒ Ventilation Vent: Bath Fan Ventilation Looking at the roof sheathing, you can see that it is deteriorated around the duct work for the ventilation fan.

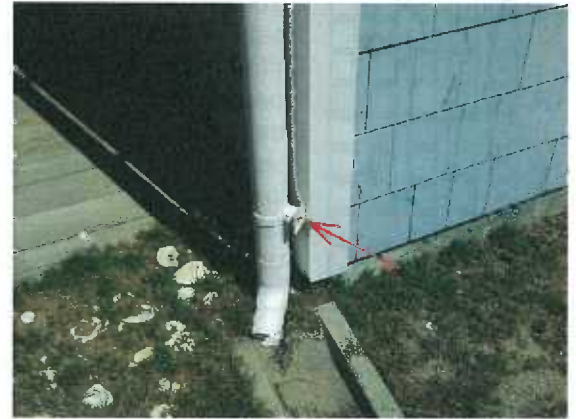
11. ☐ ☐ ☐ ☒ ☐ Downspouts: Plastic
12. ☐ ☐ ☐ ☒ ☐ Leader/Extension: Plastic Reconnect to
downspout where pulling loose

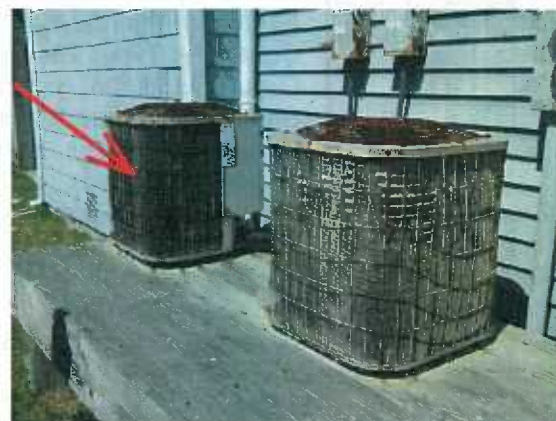
| 1. | <input type="checkbox"/> | <input type="checkbox"/> | <input type="checkbox"/> | <input type="checkbox"/> | <input checked="" type="checkbox"/> | A/C System Operation: Inoperative The unit is currently in service beyond the manufactures stated design life |

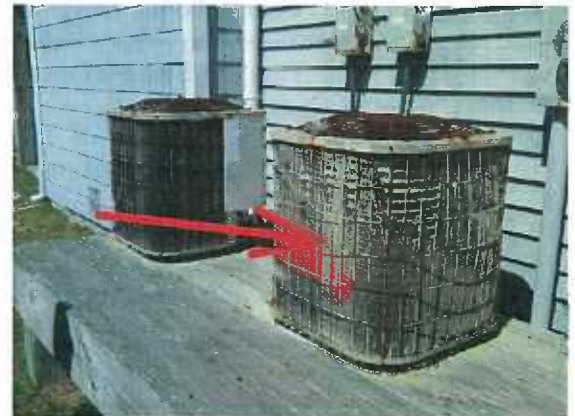
11. ☐☐☐☐☒ A/C System Operation: Inoperative The unit is currently in service beyond the manufactures stated design life

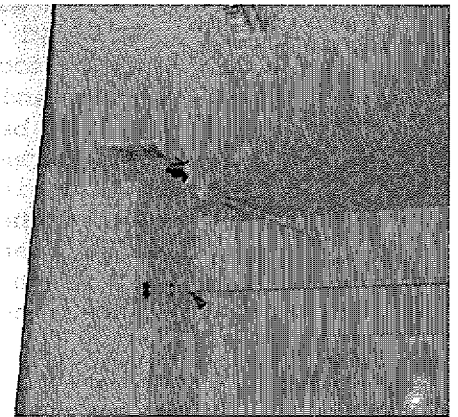
12. ☐ ☐ ☐ ☐ ☒ Ceiling: Drywall There is damage to the drywall above the toilet. This was probably cause by the defective roof ventilation vent.

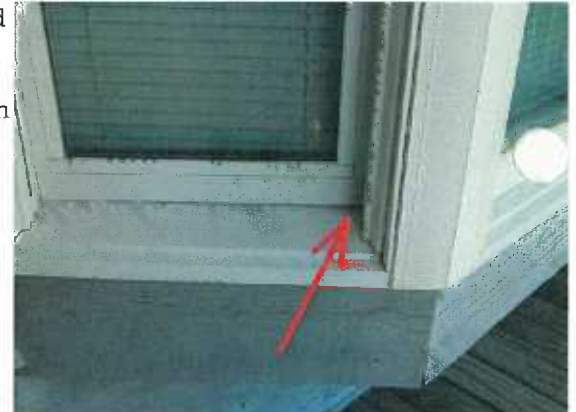
13. ☐ ☐ ☐ ☐ ☒ Windows: Andersen, Double Hung, Tilt and Wash The bay window in the kitchen eating area. The outer end of this window unit is sagging down ward. When viewing the window from the outside, you can see that the operating window sash on the sides do not fit squarely in the window frames.

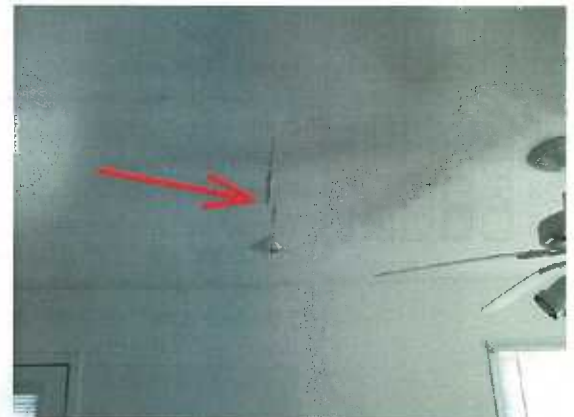
7. ☒ ☐ ☐ ☐ ☐ Closet: Single
8. ☐ ☐ ☐ ☐ ☒ Ceiling: Drywall There is damage to the drywall ceiling.

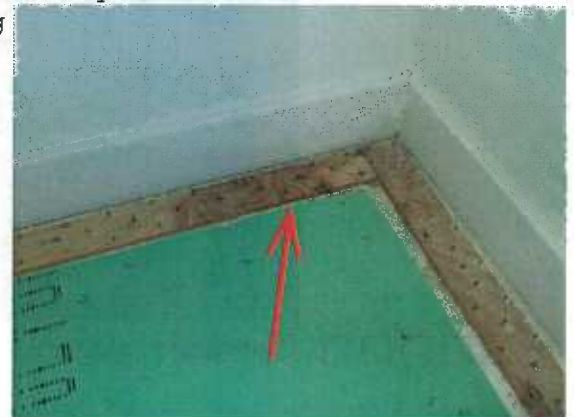
9. ☐ ☐ ☐ ☒ ☐ Walls: Drywall There is a small hole in the drywall.
10. ☐ ☐ ☐ ☒ ☐ Floor: Carpet The carpet tack strip along the unit party wall, the strip is stained and the tacks are rusty. The carpet is damaged at the entrance door. The carpet surface is stained.

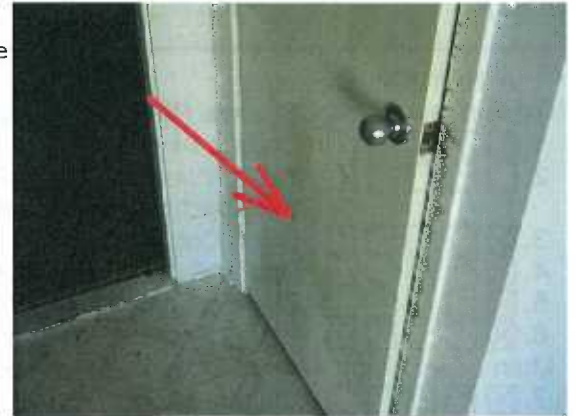
19. ☐ ☐ ☐ ☒ ☐ Doors: Painted, Flush Solid Core There is organic growth on the surface of the door.

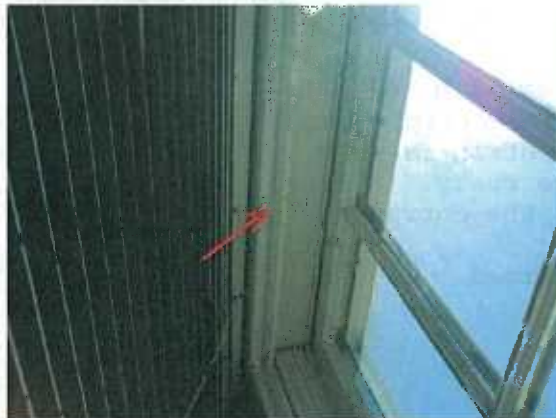
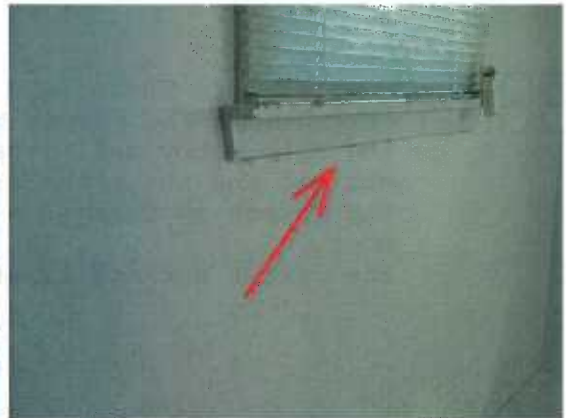
25. ☐ ☐ ☐ ☒ ☐ Windows: Andersen, Double Hung, Tilt and Wash There are signs at the bottom of this window that indicates it is leaking during periods of rain.

There are stain marks on the vinyl header piece of the top inside center window.

22. Stair Well Living Space Windows: Andersen, Double Hung, Tilt and Wash There are signs at the bottom of this window that indicates it is leaking during periods of rain. There are stain marks on the vinyl header piece of the top inside center window.

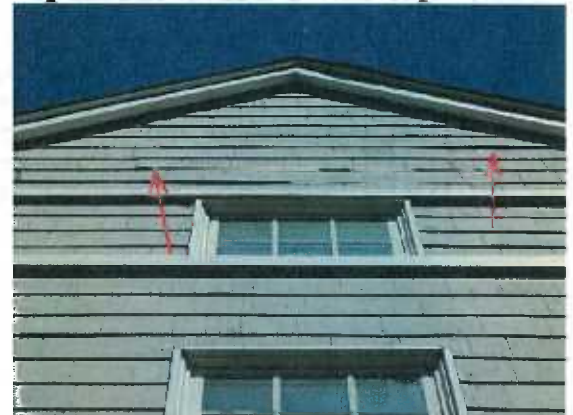
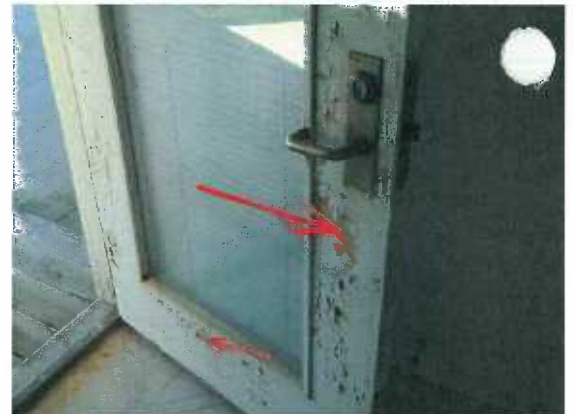
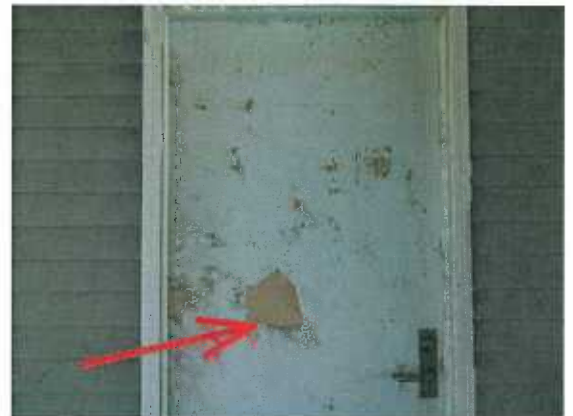
1. **Exterior Walls Exterior Surface Type:** Horizontal Wood Ship Lap Siding The exterior of the house should be pressure washed and repainted. There are several pieces of wood lap siding that are split and need to be replaced.
2. **Accent Walls Exterior Surface Type:** Plywood Panels with machine shake appearance. The machine shake look plywood panels, the nails are loose in several places. The exterior walls should be examined and the loose siding re nailed. The exterior of the house should be pressure washed and repainted.
3. **Entry Doors:** Ground Front, Fiberglass, Full View Glass Paint is peeling from the door surface. It needs to be re painted.
4. **Entry Door:** Ground Utility Room, Fiberglass, Flush Solid Core Paint is peeling from the door surface. It needs to be repainted.

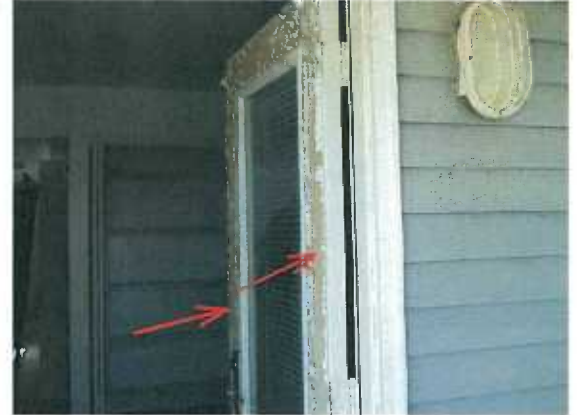
5. Entry Door: Main Living Area, Fiberglass, Full View Glass Paint is peeling from the door surface. It needs to be re painted.

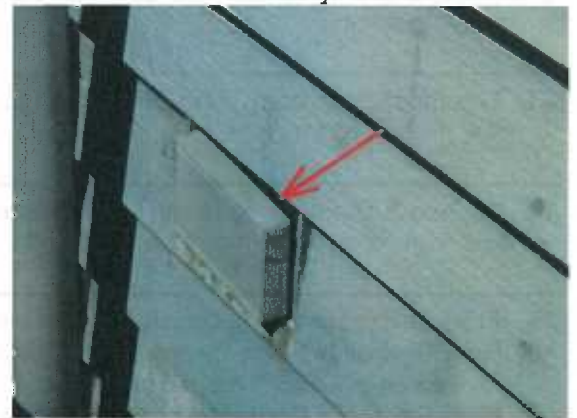
6. Window Screens: Metal wire There are several screens at various location in the house that are not installed in the windows. No effort was made to inventory the windows.
7. Exterior Electric Outlets: Exterior, Surface Mount The exterior electrical outlets are not properly mounted to the wall.

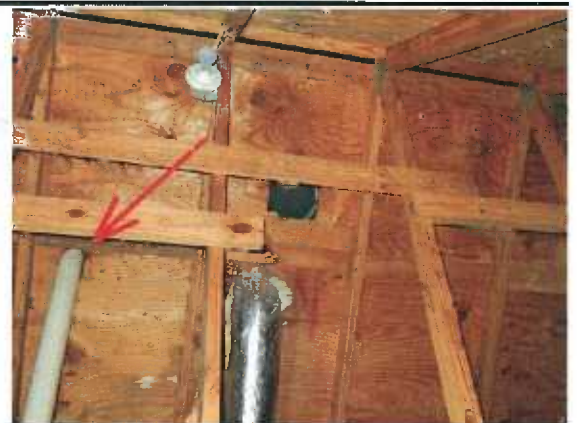
8. Plumbing Vents: PVC When inside the attic, you can see daylight around the edges of the 3 inch vent pipe. This is a good indication that is leaking.

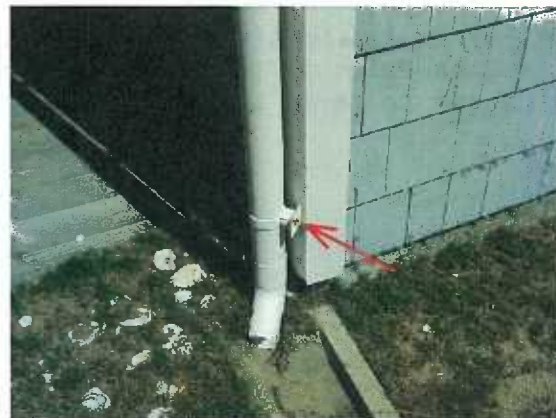
11. Leader/Extension: Plastic Reconnect to downspout where pulling loose

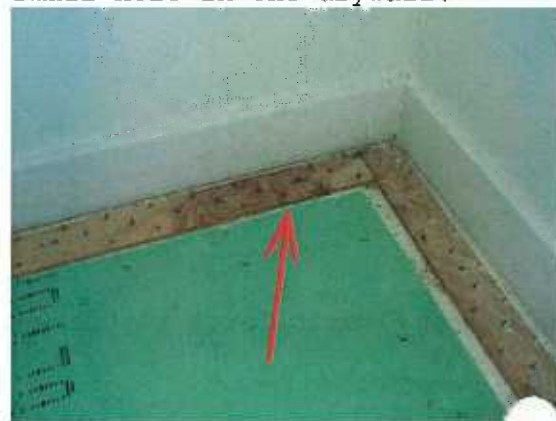
18. Ground Level Utility/Storage Room Living Space Walls: Paneling, Painted There is presence of organic growth on the painted plywood walls of this room.
19. Main Level Living Area Living Space Walls: Drywall There is a small hole in the drywall.
20. Main Level Living Area Living Space Floor: Carpet The carpet tack strip along the unit party wall, the strip is stained and the tacks are rusty. The carpet is damaged at the entrance door. The carpet surface is stained.

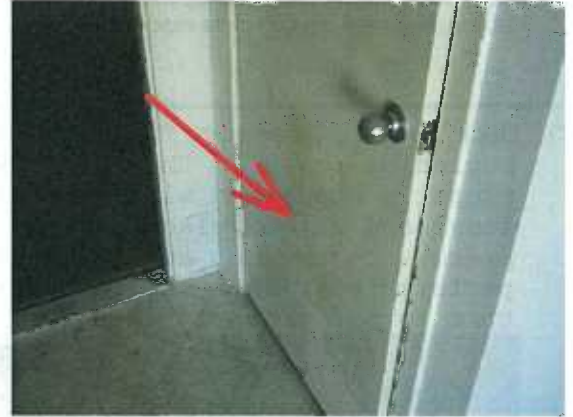
21. Ground Level Entry Living Space Doors: Painted, Flush Solid Core There is organic growth on the surface of the door.

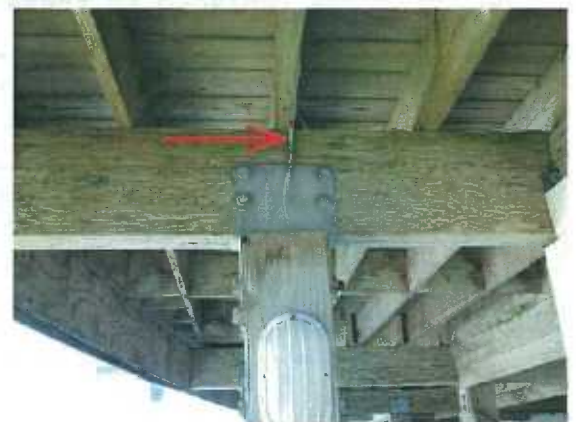
5. Exterior Lighting: Exterior, Surface Mount There is a exterior light under the front deck that was wired with interior romex wiring that should have been installed in electrical conduit. There is a light installed for the rear stairs. The interior romex wiring for this light should have been installed in electrical conduit.

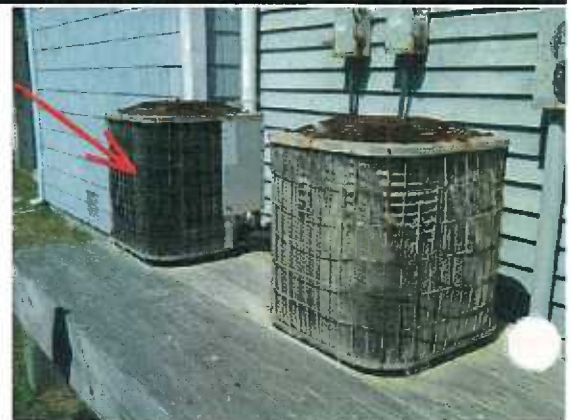
10. South Side AC System A/C System Operation: Inoperative The unit is currently in service beyond the manufactures stated design life

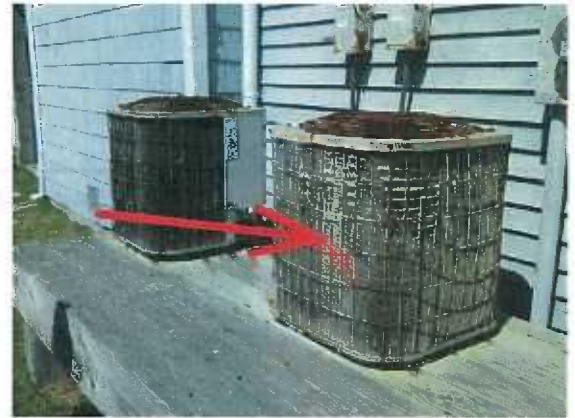
11. South Side AC System Visible Coil: Copper core with aluminum fins The aluminum fins surrounding the copper coil are becoming deteriorated and falling away from the copper coil. The aluminum fins are present to dissipate the heat from the copper coil and when the fins are no longer present the coil will over heat and the condenser will cease to function.
12. South Side AC System Refrigerant Lines: Rubbertex Insulation The black rubbertex insulation on the copper tubing is deteriorated and should be replaced.
13. South Side AC System Electrical Disconnect: Tumble switch The HVAC electric disconnect box is very rusty.
14. South Side AC System A/C System Operation: Inoperative The unit is currently in service beyond the manufactures stated design life

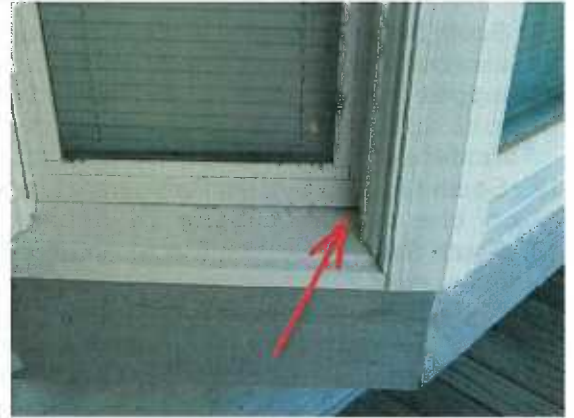
20. Kitchen & Dining Area, Main Level Kitchen Windows: Andersen, Double Hung, Tilt and Wash The bay window in the kitchen eating area. The outer end of this window unit is sagging down ward. When viewing the window from the outside, you can see that the operating window sash on the sides do not fit squarely in the window frames.

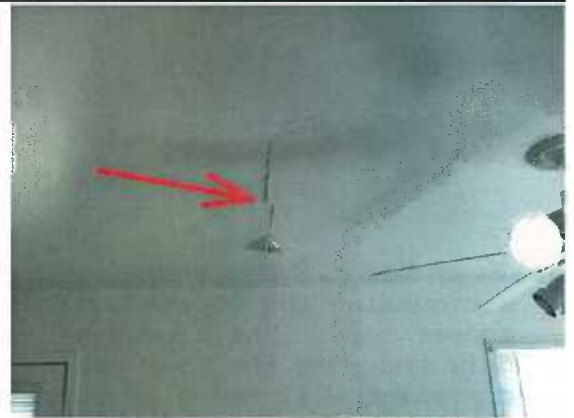
21. Main Level Living Area Living Space Ceiling: Drywall There is damage to the drywall ceiling.

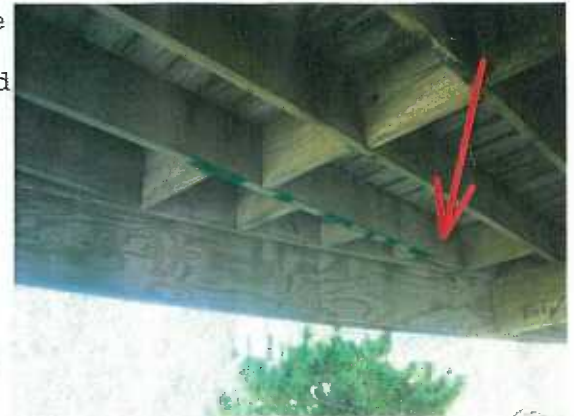
Deck: Front, Pressure Treated Wood There is one floor joist near the front of the deck that is not properly supported with a metal joist hanger.

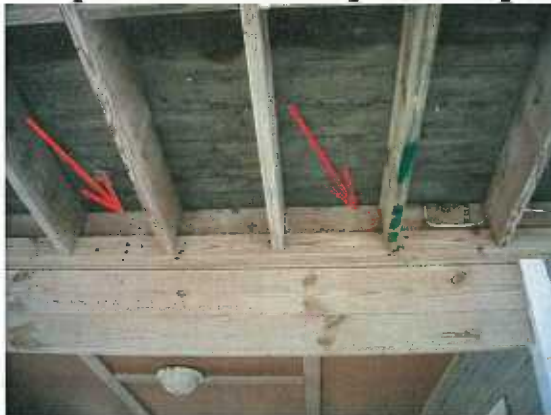
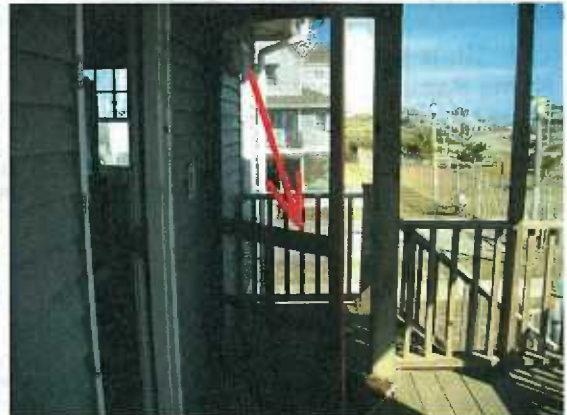
Porch: Rear, Pressure Treated Wood The porch floor ledger is not bolted to the structure. The porch screen door is damaged. Screen panels for the porch are missing or damaged.

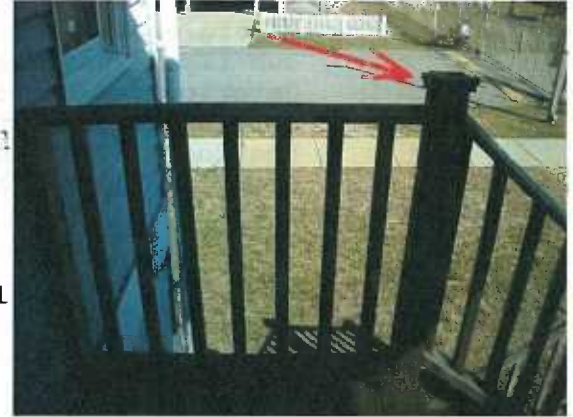
4. ☐ ☐ ☐ ☒ ☐ Stairs/Landing: Rear Stairs & Landing, Pressure Treated Wood The wood pickets are loose or out of place. The nails used to secure the pickets are rusty/deteriorated. The decorative wood trim at the top of the handrail post, most of this trim is missing or deteriorated. There is a 12 inch opening at the top of the stairs between the porch post and the handrail post, there is no handrail in this area. The opening is large enough for a small child to fall through.

2. Stairs/Landing: Rear Stairs & Landing, Pressure Treated Wood The wood pickets are loose or out of place. The nails used to secure the pickets are rusty/deteriorated. The decorative wood trim at the top of the handrail post, most of this trim is missing or deteriorated. There is a 12 inch opening at the top of the stairs between the porch post and the handrail post, there is no handrail in this area. The opening is large enough for a small child to fall through.

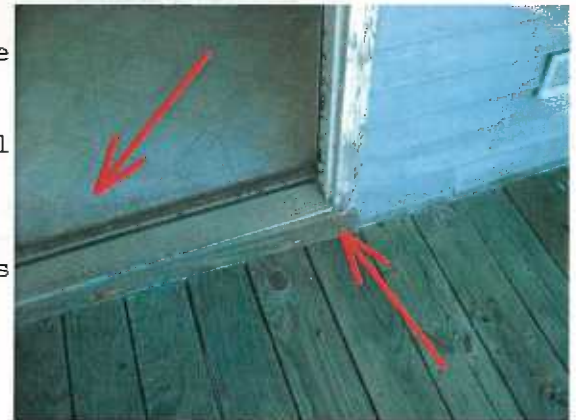
7. ☐ ☐ ☐ ☒ ☐ Type: Plywood Panels with machine shake appearance. All exterior wall surfaces should be examined and re nailed in the areas where it has become loose. The machine shake look plywood panels, the nails are loose in several places. The exterior walls should be examined and the loose siding re nailed.
8. ☒ ☐ ☐ ☐ ☐ Trim: Wood, Aluminum Covered
9. ☒ ☐ ☐ ☐ ☐ Fascia: Wood, wrapped with Aluminum Coil Stock
10. ☒ ☐ ☐ ☐ ☐ Soffits: Vinyl panels
11. ☐ ☐ ☐ ☐ ☒ Entry Doors: Ground Front, Fiberglass, Full View Glass The sill support at the bottom of the door exterior is out of place and should be re nailed or replaced. There are stains on the vinyl floor inside the door indicating that moisture is migrating under the door and into the house at times of rain. The door hardware is defective or needs cleaning. The door will not lock properly.

5. Accent Walls Exterior Surface Type: Plywood Panels with machine shake appearance. All exterior wall surfaces should be examined and re nailed in the areas where it has become loose. The machine shake look plywood panels, the nails are loose in several places. The exterior walls should be examined and the loose siding re nailed.

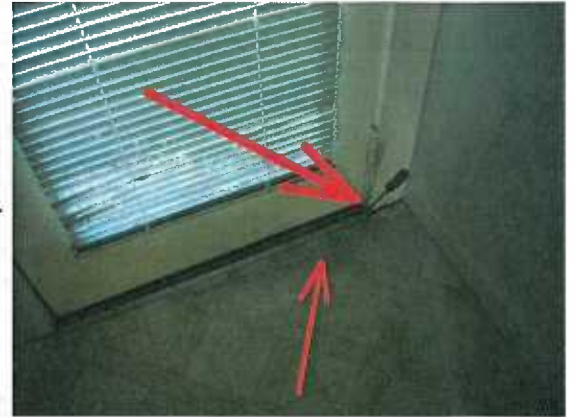
14. ☐ ☐ ☐ ☒ ☐ Entry Door: Kitchen/Dining Area, Fiberglass, Fullview Glass The sub-floor just inside the door is deteriorated, this is caused by moisture migration under the bottom of the door. The vinyl flooring is deteriorated by the moisture migration.

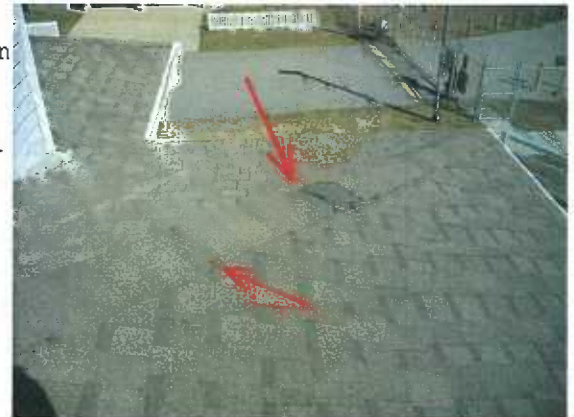
2. ☐ ☐ ☐ ☒ ☐ Material: Asphalt shingle There are several ridge cap shingles missing from the lower roof. There were several roofing nails observed that the nail heads are rusty.

9. All Roof Areas Roof Surface Material: Asphalt shingle There are several ridge cap shingles missing from the lower roof. There were several roofing nails observed that the nail heads are rusty.

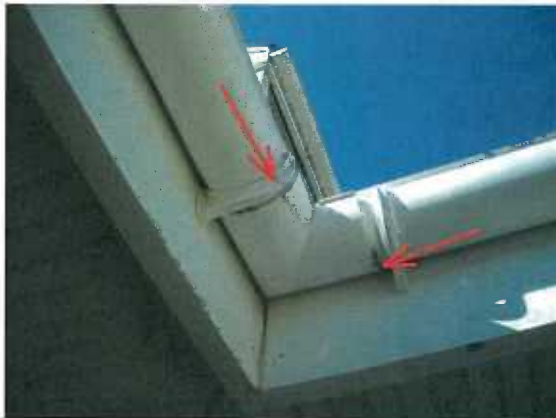
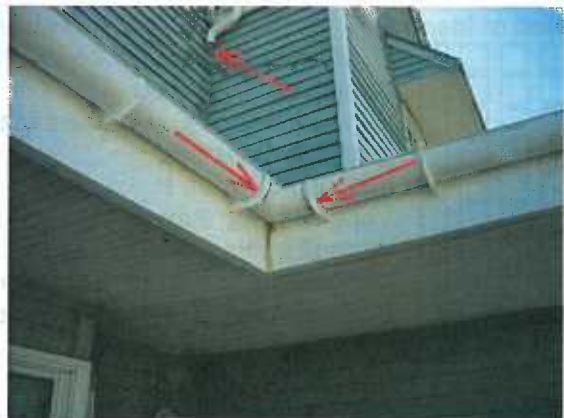
9. ☐ ☐ ☐ ☐ ☒ Gutters: Plastic There connections at the plastic gutter pipe sections where the glue has failed and water is leaking from the gutters in these area.

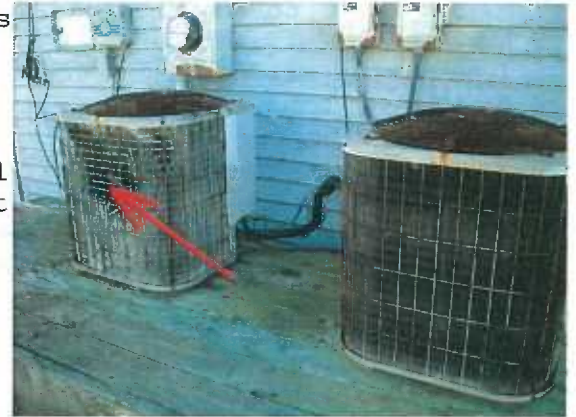
| 10. | <input type="checkbox"/> | <input type="checkbox"/> | <input type="checkbox"/> | <input checked="" type="checkbox"/> | <input type="checkbox"/> | Electrical Disconnect: Tumble switch The metal disconnect box is very rusty. |

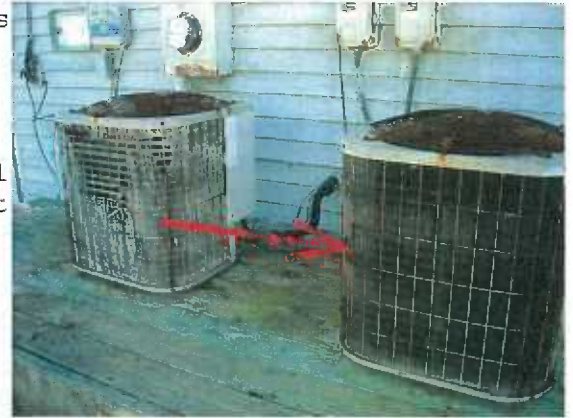
18. ☐☐☐☐☒ Visible Coil: Copper core with aluminum fins
The aluminum fins surrounding the copper coil are becoming deteriorated and falling away from the copper coil. The aluminum fins are present to dissipate the heat from the copper coil and when the fins are no longer present the coil will over heat and the condenser will cease to function.

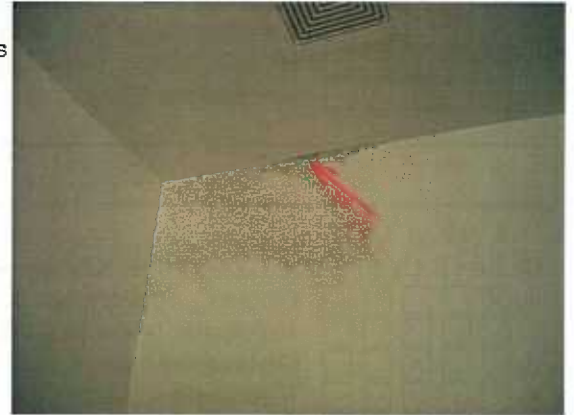
| 1. | <input type="checkbox"/> | <input type="checkbox"/> | <input type="checkbox"/> | <input checked="" type="checkbox"/> | <input type="checkbox"/> | Ceiling: Drywall The drywall is defective in the ceiling area where it intersects with the wall. |

13. Main Level Powder Room Bathroom Ceiling: Drywall The drywall is defective in the ceiling area where it intersects with the wall.

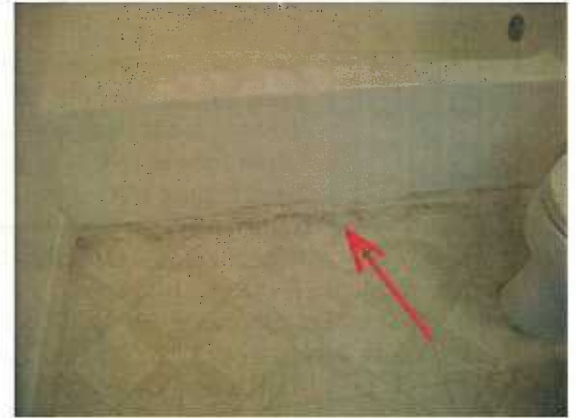
13. ☐ ☐ ☐ ☒ ☐ Floor: Vinyl floor covering The vinyl flooring is stained in the area of the tub.

14. Top Floor Hallway Bathroom Floor: Vinyl floor covering The vinyl flooring is stained in the area of the tub.

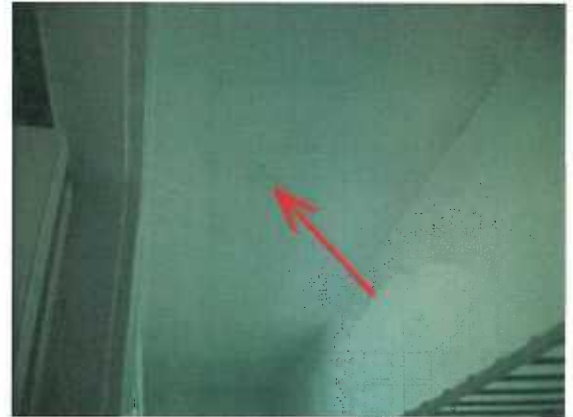
1. ☐ ☐ ☐ ☒ ☐ Closet: Single There is a stain on the drywall ceiling.

15. Top Floor East Bedroom Closet: Single There is a stain on the drywall ceiling.

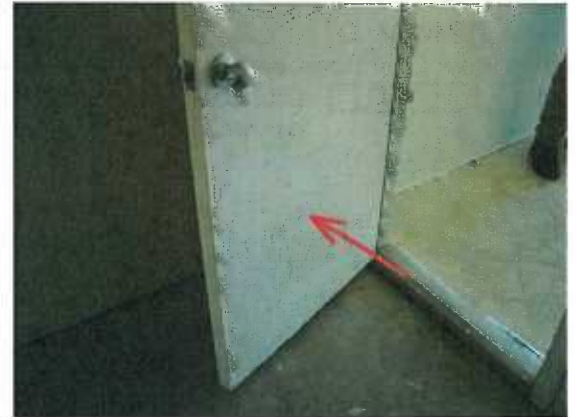
4. ☐ ☐ ☐ ☒ ☐ Doors: Painted, Flush Solid Core There is organic growth on the door surface.

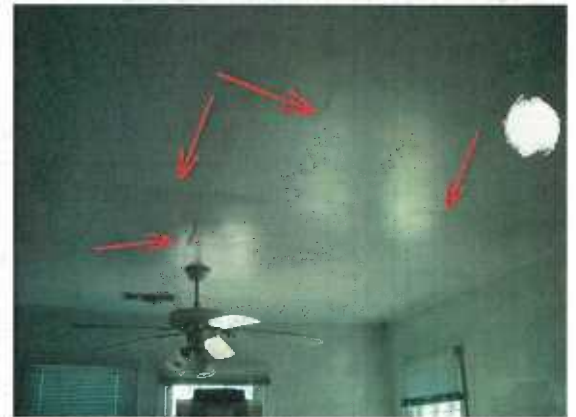
8. ☒ ☐ ☐ ☐ ☐ Closet: Single
9. ☐ ☐ ☐ ☐ ☒ Ceiling: Drywall There are cracks in the drywall ceiling. the cracks appear to follow the edges of the sheets of drywall. Also, the ceiling drywall appears to be bowing down in places.

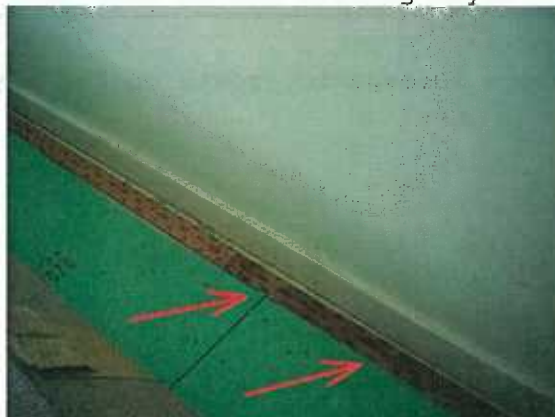
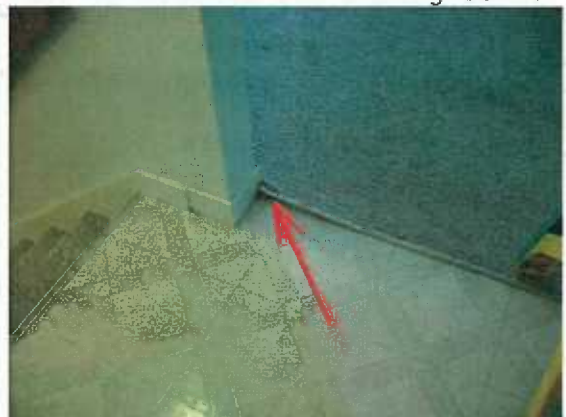
10. ☒ ☐ ☐ ☐ ☐ Walls: Drywall
11. ☐ ☐ ☐ ☒ ☐ Floor: Carpet The aluminum carpet threshold has lifted at the left corner. At the party wall, the carpet tack strip nails are rusty, indicating that the carpet has been wet in the past. This condition is in the same area as the ceiling drywall that is cracked and bowing down.

19. Main Level Living Area Living Space Floor: Carpet The aluminum carpet threshold has lifted at the left corner.
- At the party wall, the carpet tack strip nails are rusty, indicating that the carpet has been wet in the past. This condition is in the same area as the ceiling drywall that is cracked and bowing down.

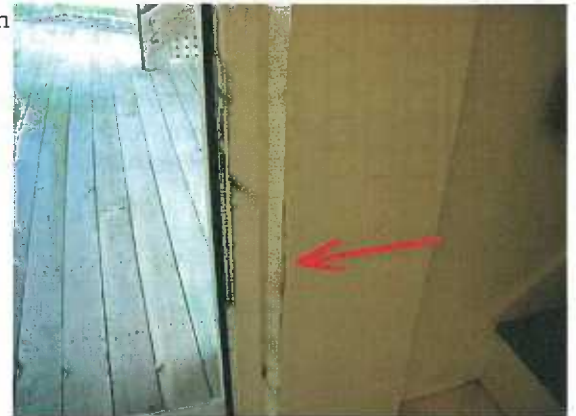
16. ☐ ☐ ☐ ☒ ☐ Closet: Single Closet door needs to be adjusted.
17. ☒ ☐ ☐ ☐ ☐ Ceiling: Drywall
18. ☐ ☐ ☐ ☒ ☐ Walls: Drywall The drywall corner bead on the 8X8 piling just inside the entry door is rusty. It is possible the moisture causing this rust could be originating at the entry door on the floor above.

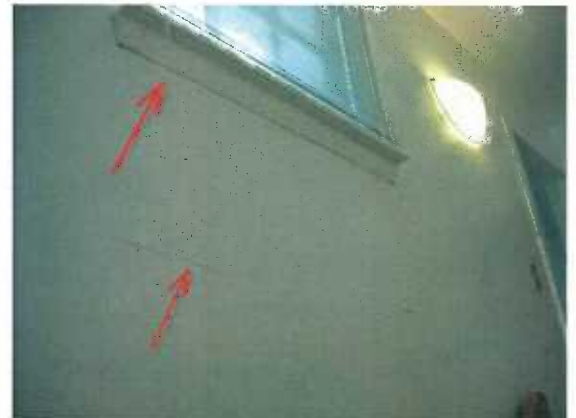
22. ☒ ☐ ☐ ☐ ☐ Ceiling: Drywall
23. ☐ ☐ ☐ ☒ ☐ Walls: Drywall The drywall under the window is deteriorated. Moisture is migrating through the window above and on the drywall.

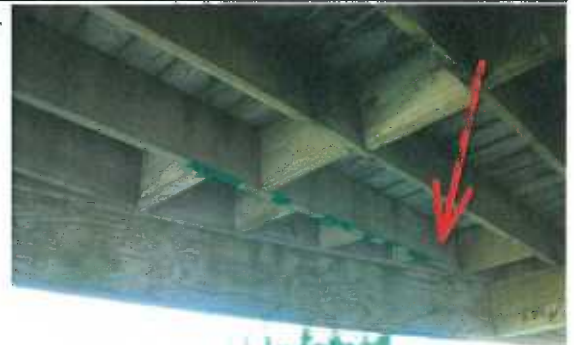
1. Deck: Front, Pressure Treated Wood There is one floor joist near the front of the deck that is not properly supported with a metal joist hanger.

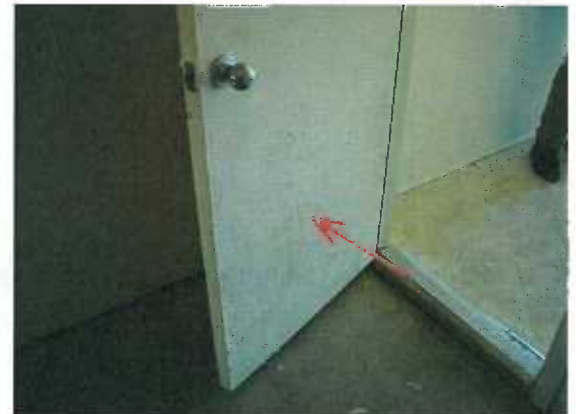
17. Ground Level Utility/Storage Room Living Space Walls: Paneling, Painted There is organic growth on the plywood paneling walls.
18. Ground Level Utility/Storage Room Living Space Doors: Painted, Flush Solid Core There is organic growth on the floor surface.

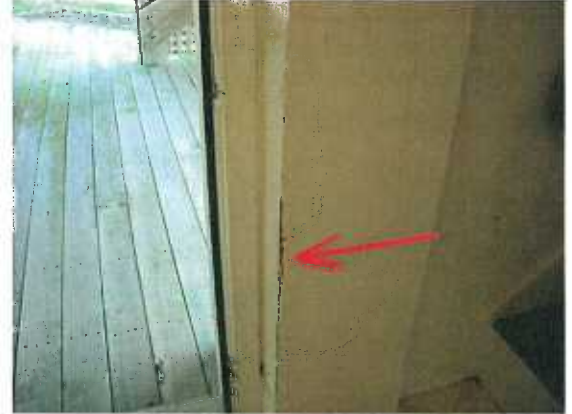
21. Ground Level Entry Living Space Walls: Drywall The drywall corner bead on the 8X8 piling just inside the entry door is rusty. It is possible the moisture causing this rust could be originating at the entry door on the floor above.

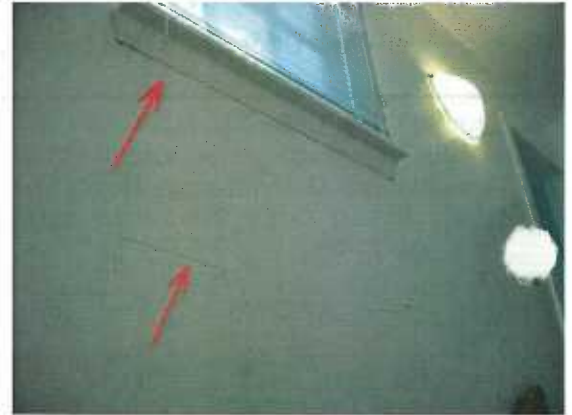
22. Interior Stairs Living Space Walls: Drywall The drywall under the window is deteriorated. Moisture is migrating through the window above and on the drywall.

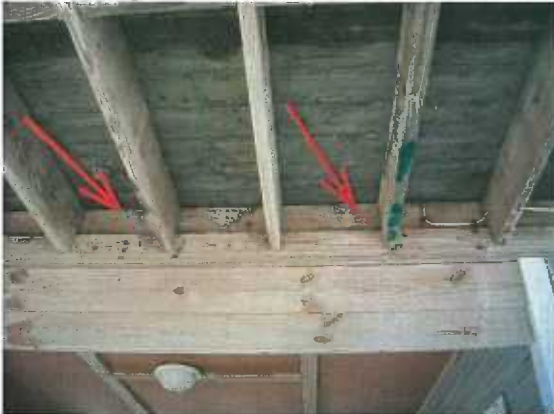
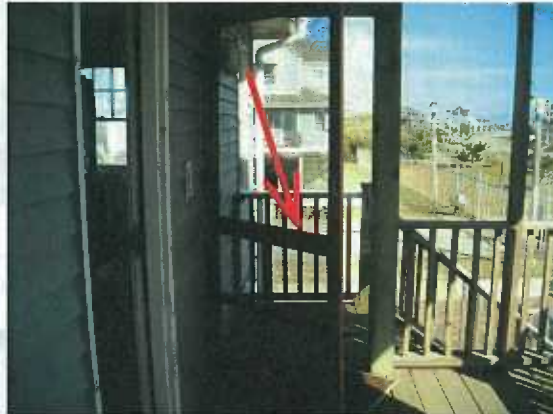
1. Porch: Rear, Pressure Treated Wood The porch floor ledger is not bolted to the structure. The porch screen door is damaged. Screen panels for the porch are missing or damaged.

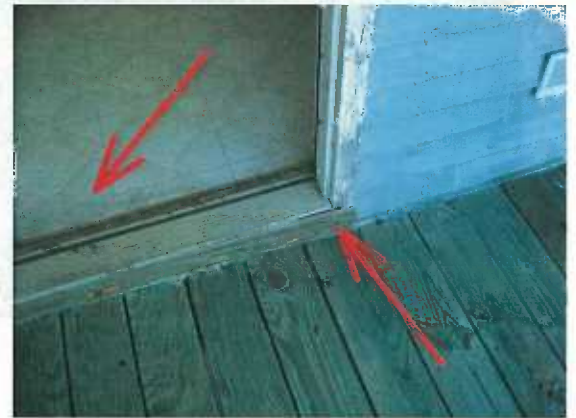
2. Entry Doors: Ground Front, Fiberglass, Full View Glass The sill support at the bottom of the door exterior is out of place and should be re nailed or replaced. There are stains on the vinyl floor inside the door indicating that moisture is migrating under the door and into the house at times of rain. The door hardware is defective or needs cleaning. The door will not lock properly.

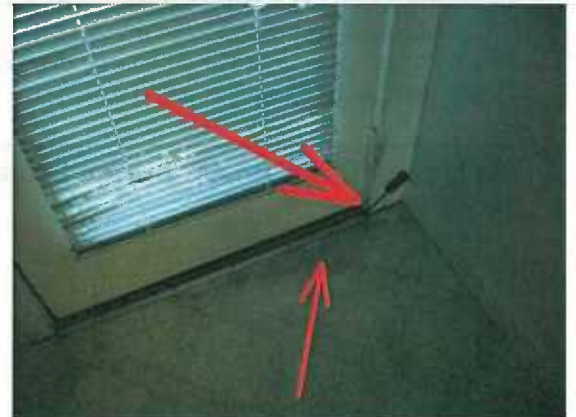
3. Entry Door: Kitchen/Dining Area, Fiberglass, Fullview Glass The sub-floor just inside the door is deteriorated, this is caused by moisture migration under the bottom of the door. The vinyl flooring is deteriorated by the moisture migration.

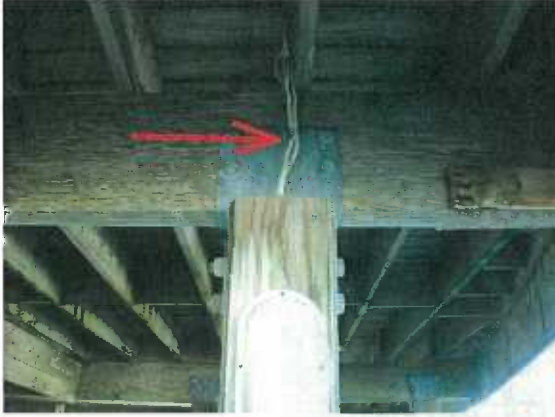
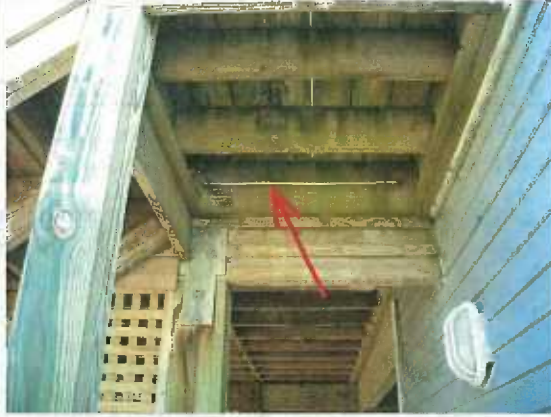
Exterior Lighting: Exterior, Surface Mount There is a exterior light under the front deck that was wired with interior romex wiring that should have been installed in electrical conduit. There is a light installed for the rear stairs. The interior romex wiring for this light should have been installed in electrical conduit.

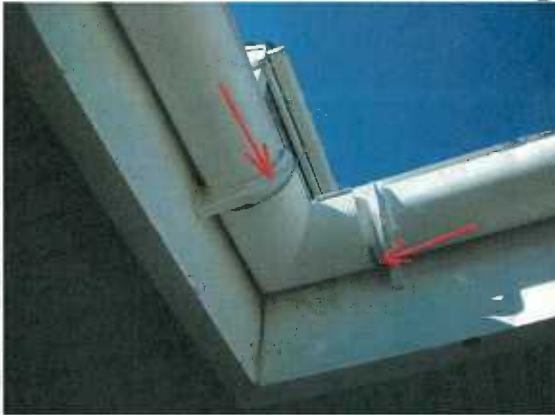
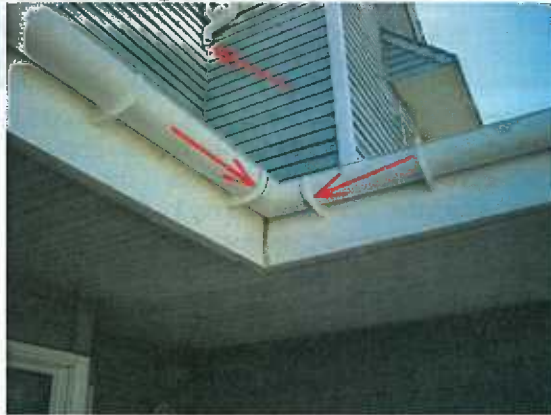
5. **Gutters:** Plastic There connections at the plastic gutter pipe sections where the glue has failed and water is leaking from the gutters in these area.

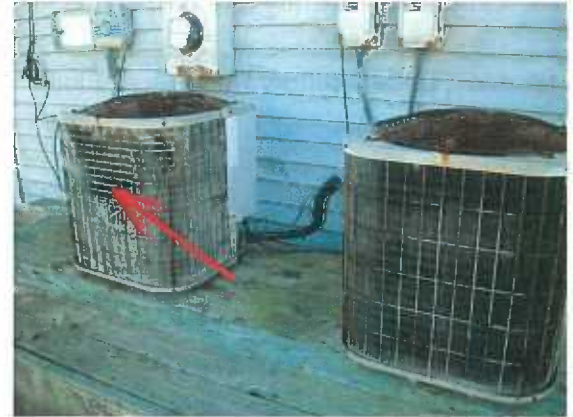
9. North Side AC System Visible Coil: Copper core with aluminum fins The aluminum fins surrounding the copper coil are becoming deteriorated and falling away from the copper coil. The aluminum fins are present to dissipate the heat from the copper coil and when the fins are no longer present the coil will over heat and the condenser will cease to function.

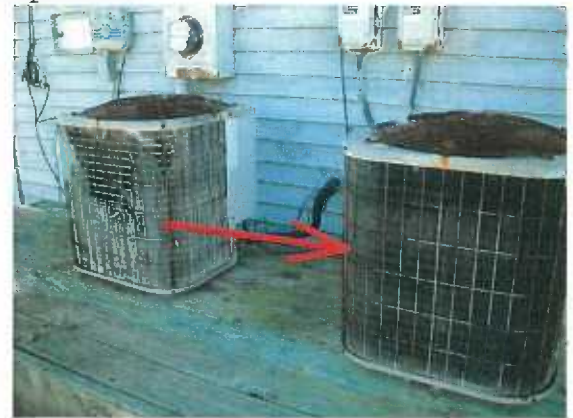
11. North Side AC System Visible Coil: Copper core with aluminum fins The aluminum fins surrounding the copper coil are becoming deteriorated and falling away from the copper coil. The aluminum fins are present to dissipate the heat from the copper coil and when the fins are no longer present the coil will over heat and the condenser will cease to function.
